***FLOODS
IN THE CZECH REPUBLIC
IN JUNE
2013***

***FLOODS IN THE CZECH REPUBLIC
IN JUNE
2013***

This publication presents key outputs of the project „*Evaluation of Floods in the Czech Republic in June 2013*“ guaranteed by the Ministry of Environment of the Czech Republic.

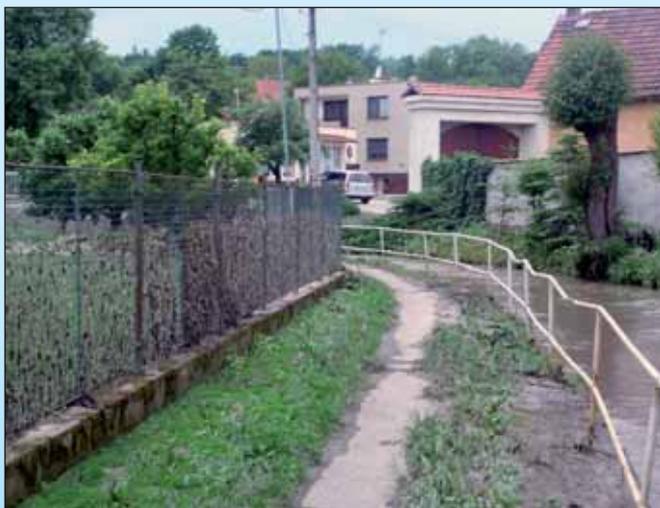
Fig. 2.3 Traces of Peak Level after Flood in Běloky on Dolanský Stream. (Source: official website of the village of Běloky).

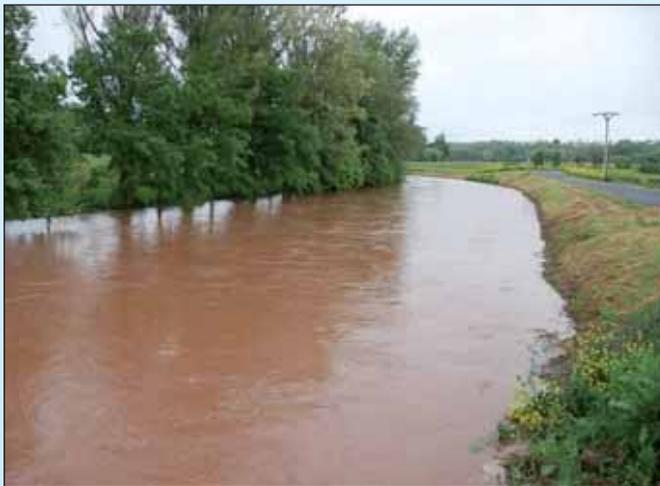
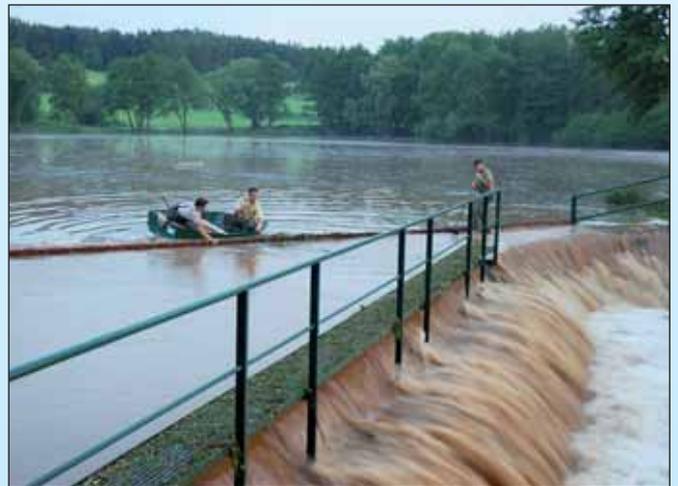
Fig. 2.12 Flood-Swollen Blšanka Stream at Stránky Water Gauge (left) and Water Flowing over Safety Spillway of Lubenecký Pond on Struhařský Stream at the Edge of Village of Lubenec (right). (Source: Žatecký a Lounský deník).

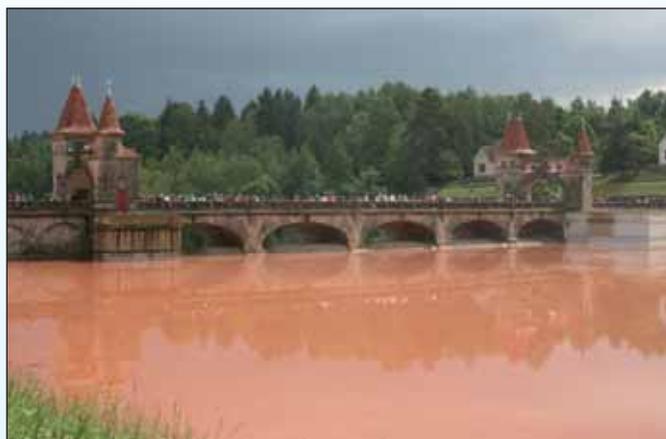
Fig. 4.9 Les Království Reservoir – Reservoir Filled up to Safety Spillway Level (Source: VODNÍ DÍLA – TBD a. s.).

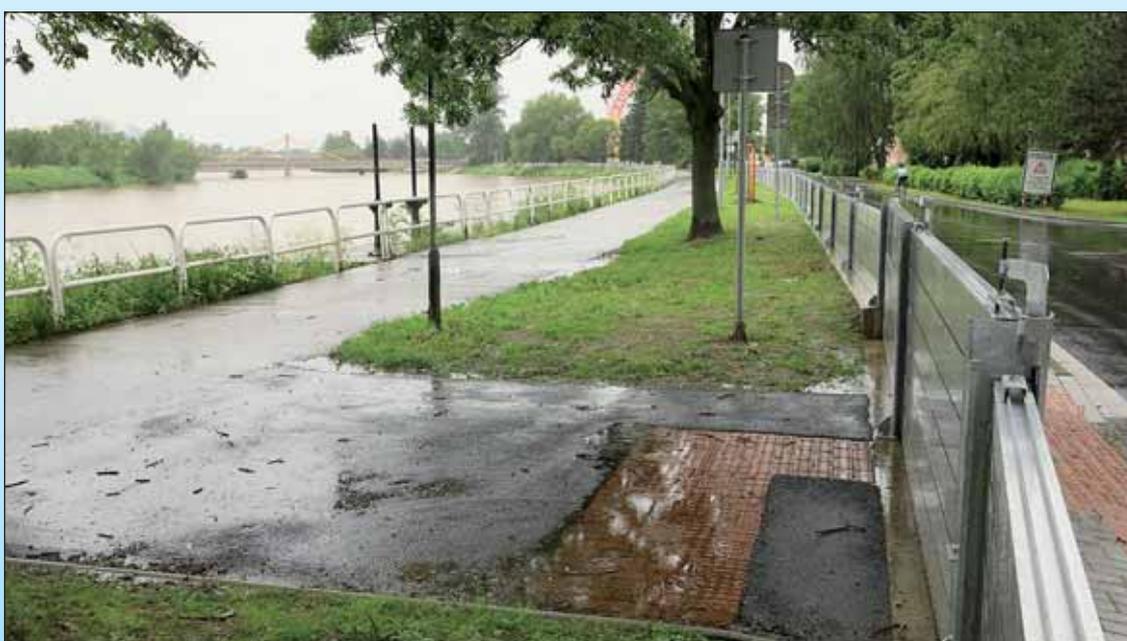
Obr. 4.16 Mobile Flood Control Barriers along the Vltava River in České Budějovice (Photo by Libor Sváček).

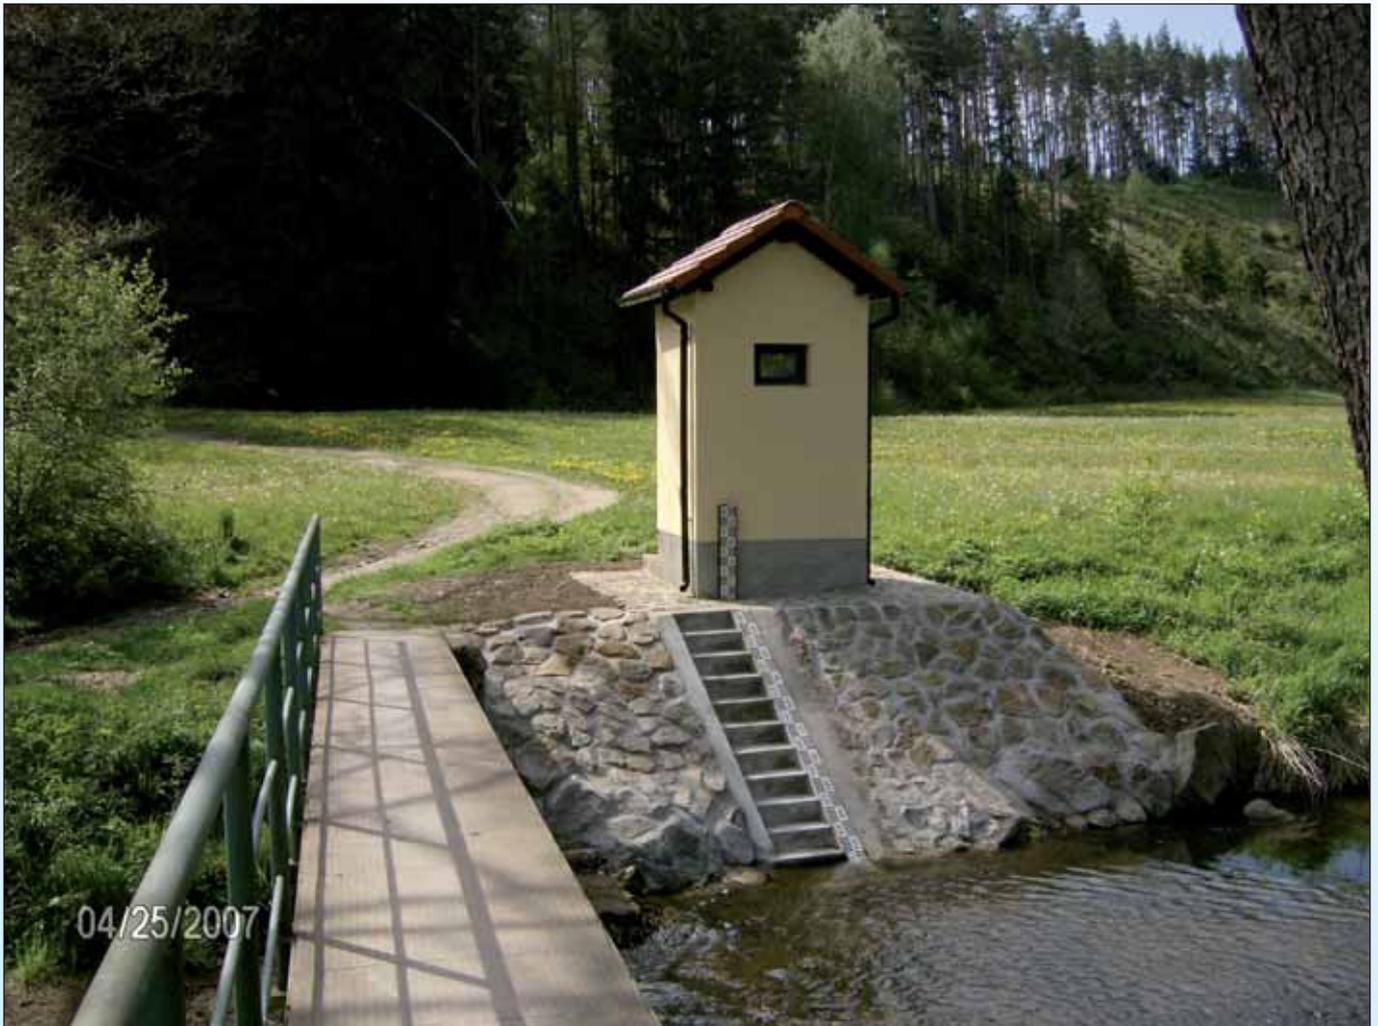
Fig. 7.3 Reconstructed Station Slovénice on the Chotýšanka Stream. The Station remained functional during the flood in June 2013 with the peak exceeding the 100-year flow rate.
